VSC-24 Lead Canister Inspection

Suzanne Leblang, Entergy
Steven Sisley, EnergySolutions

- ▶ VSC-24 Ventilated Storage Cask System CoC Renewal Application Submitted to NRC
 - ❖ Requested 40-year renewal term to May 7, 2053
 - ❖ NRC currently reviewing application
- ▶ Lead Canister Inspection performed and included with CoC renewal application per NUREG-1927
 - ❖ Performed at Palisades on May 21-24, 2012
 - ❖ Cask No. VSC-15

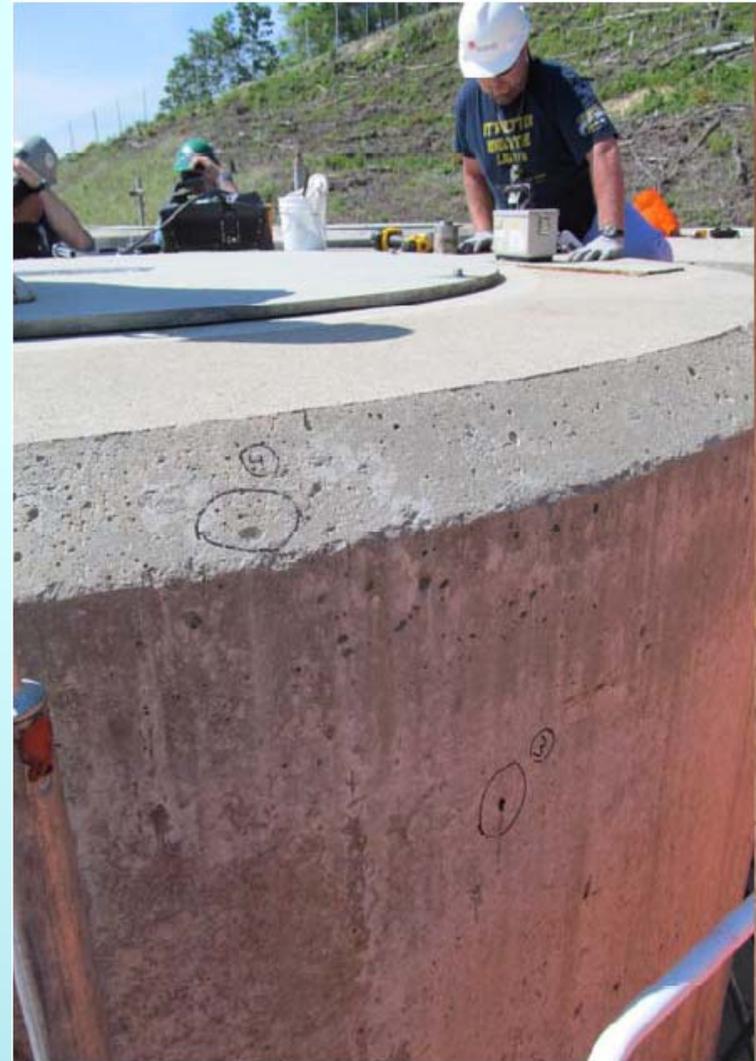
VCC Concrete Exterior

- ▶ Visual examination of concrete side & top surfaces for aging effects
- ▶ Concrete in good overall condition
 - ❖ Small number of “bug-holes”
 - ❖ No other aging effects identified

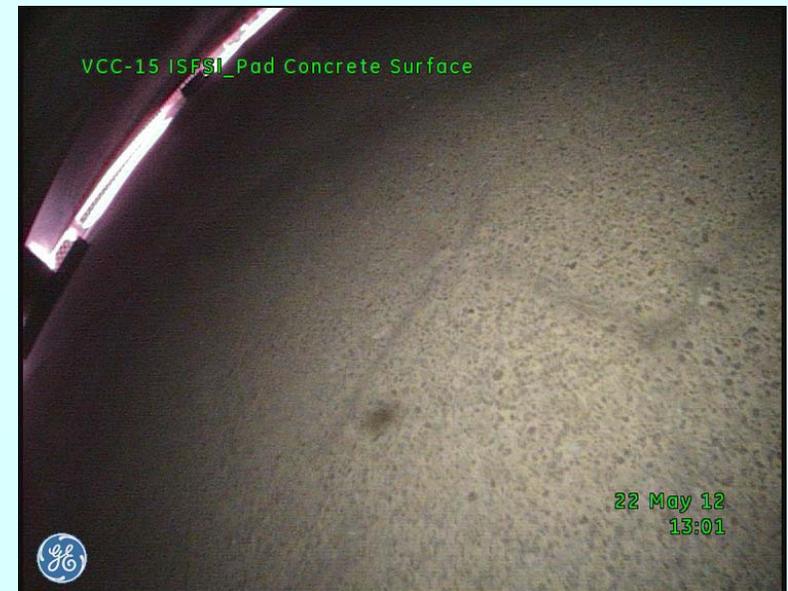
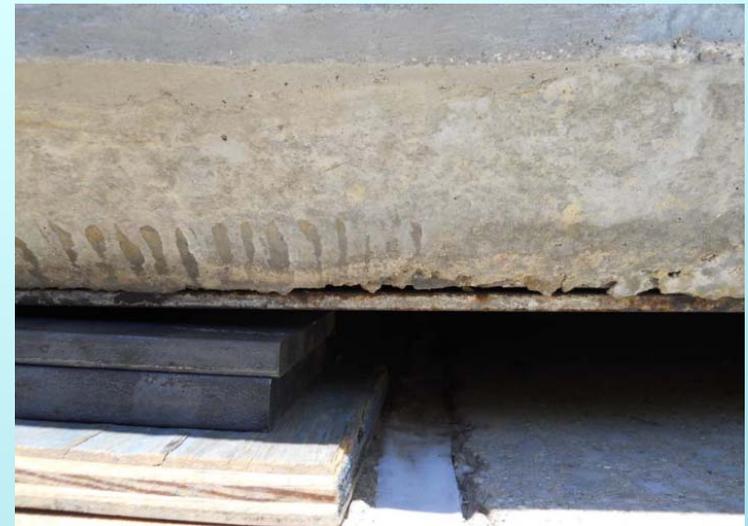
VCC Bottom Surface

- ▶ Lifted cask using jacks and performed remote visual examination cask bottom surface and underlying ISFSI pad
- ▶ Cask bottom and ISFSI pad surfaces in good overall condition
- ▶ Small amount of debris, dust, bugs found
- ▶ Slight separation of bottom plate from concrete (due to jacking)

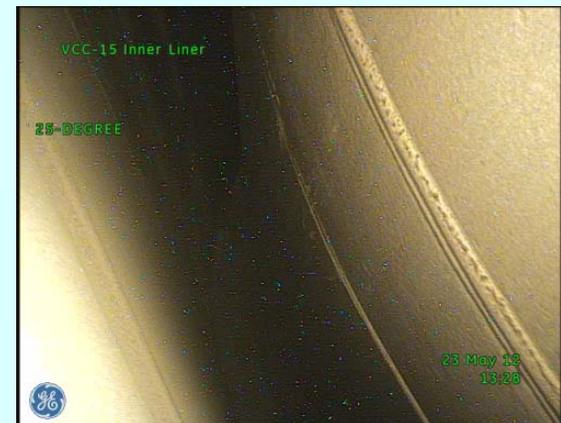
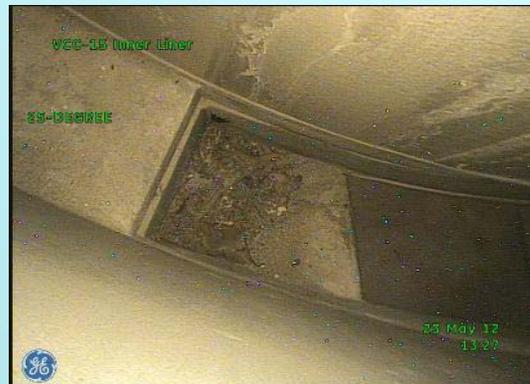
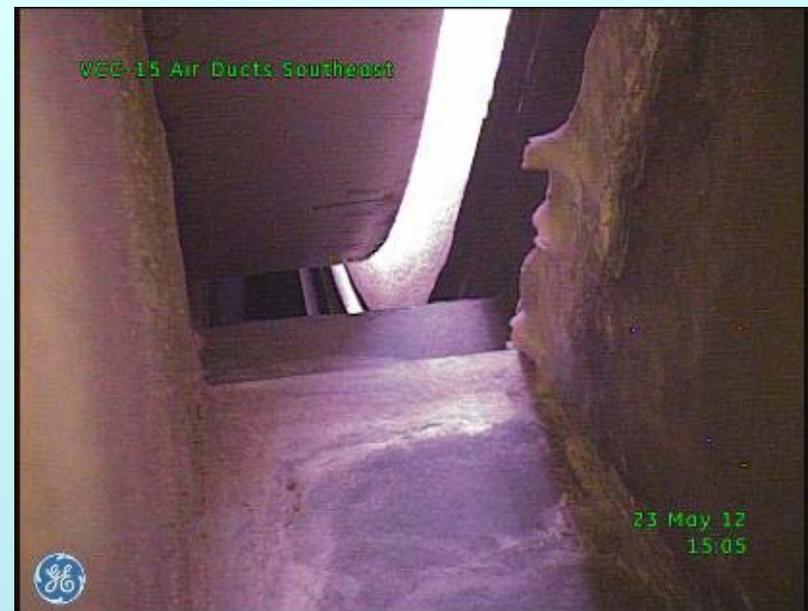
MSB Shell, VCC Liner and Vents

- ▶ Remote visual inspection of VCC annulus and vents
- ▶ Surfaces in good overall condition
- ▶ Small amount of debris inside VCC
 - ❖ Leaves/bugs collected at bottom of VCC annulus
 - ❖ Small mineral deposits (e.g., stalactites) at inside end of outlet vent
- ▶ Coating on MSB and VCC liner in good condition – no degradation or corrosion

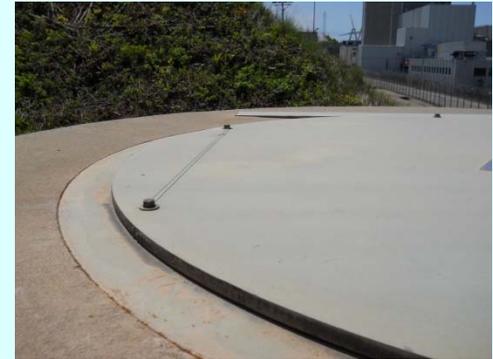
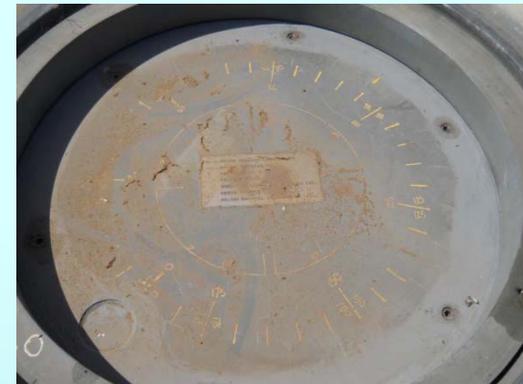
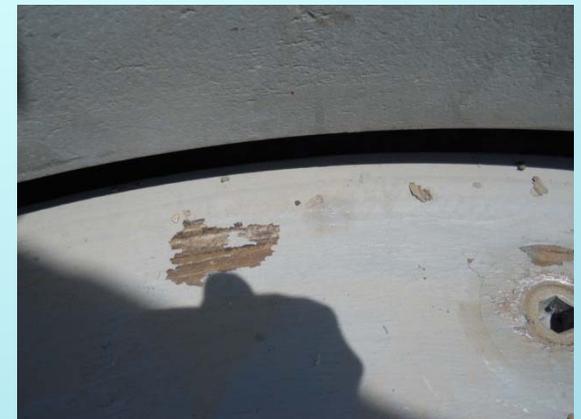
VCC Lid, MSB Top End

- ▶ Removed VCC lid and performed visual inspection MSB top end
- ▶ VCC lid in good condition
 - ❖ Coating intact
 - ❖ Lid bolts acceptable – minor corrosion
 - ❖ Lid gasket – no evidence of leakage
- ▶ MSB top end in good condition
 - ❖ Coating intact – few small “bubbled” areas
 - ❖ Small areas of coating scraped off when temporary shielding removed
 - No corrosion on underlying steel
 - Scraped areas re-coated
